## Peri-implant bone tissues around retrieved human implants after time periods longer than 5 years: a retrospective histologic and histomorphometric evaluation of 8 cases

**Abstract** Only rarely, it is possible to find in the literature histological reports of human retrieved implants, especially after several years of functional loading. These implants can help us in understanding the reactions of peri-implant bone. The aim of this study was to perform a histologic and histomorphometric analysis of the peri-implant tissues behavior and of the bone–titanium interface in titanium dental implants retrieved from patients after time periods longer than 5 years. The archives of the Implant Retrieval Center of the Dental School of the University of Chieti-Pescara, Italy were searched for human dental implants, retrieved after a loading period of more than 5 years. A total of 8 implants were found: 3 of these had been retrieved after 5 years, 1 after 6 years, one after 10 years, 1 after 14 years, 1 after 18 years, 1 after

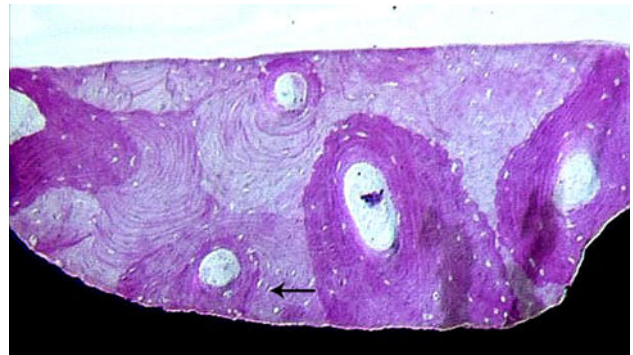
**Fig. 3** Implant 6. Osteons with Haversian canals were present inside some threads, in close proximity to the interface. The transversally oriented collagen fibers are indicated by an *arrow*. Acid Fuchsin-toluidine blue  $\times 40$

Traini et al. [12, 14] showed a strong correlation between compressive stresses and collagen fibers orientation, and, in fact, in the dental implant removed after 5 years of functional loading, it was possible to observe a change in the microstructure of the bone, with an increase in the transversally oriented collagen fibers. The orientation of the collagen fibers was strictly dependent on the shape of the implant. Bone remodeling areas were frequently observed in the peri-implant bone of these implants. It has been shown that remodeling cycles are necessary to obtain a high level of the organization of the peri-implant bone that shows good mechanical properties [27, 34]. The present results indicated that after many years of functional loading, all these retrieved implants were well integrated and presented high BIC, with no trace of fibrous connective tissue at the bone–implant interface or the presence of a downgrowth of the epithelium. This fact is very important because the efficacy of any given implant is related to a large part on the stability and integration between implant and bone [5]. The peri-implant bone had undergone remodeling as indicated by the presence of Haversian systems near the implant bone interface.

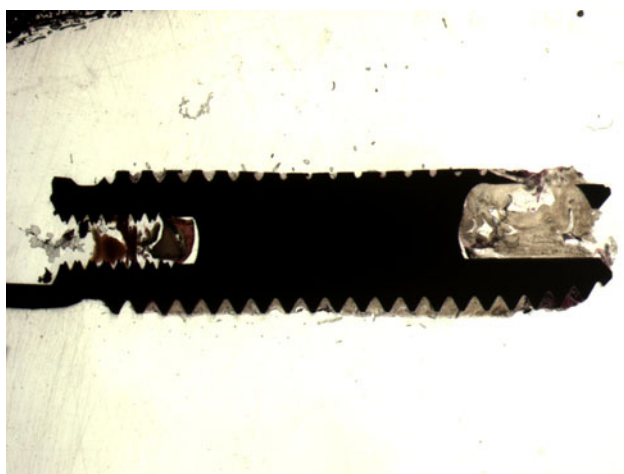
**Fig. 6** Implant 4. Compact, mature bone is present along the implant perimeter. No connective tissue can be observed. Acid Fuchsin–toluidine blue  $\times 8$

interface (Fig. 5). The BIC was evaluated in the three best threads because the interface of same samples was partially damaged. The values varied from 94 to 100 % (Figs. 6, 7).
