# Changes in the Abutment/Implant Interface in Morse Taper Implant Connections After Mechanical Cycling: A Pilot Study

Sergio Alexandre Gehrke, DDS, Prof, PhD<sup>1</sup>/Frederico de Araújo Pereira, DDS<sup>2</sup>

**Purpose:** The aim of this study was to measure and compare, using scanning electron microscopy, the implant-abutment interface of a Morse taper system before and after cyclic loading. **Materials and Methods:** Four Morse cone implants and four solid abutments were used. These abutments had been machined to reduce the diameter of the part corresponding to the site of prosthesis cementation. They were then screwed onto the implants and torqued to 25 N. Under a scanning electron microscope, 32 images (16 before and 16 after cycling) of the interfaces were obtained under  $\times 1,000$  and  $\times 5,000$  magnification. The samples were subjected to 345,600 cycles with a fatigue testing machine, in which the applied load was 80 N and the frequency was 4 Hz, to simulate chewing. With appropriate software (Image Tool 3.0), the marginal gaps of the interfaces before and after load cycling were measured. The data were analyzed with the Student t test at a significance

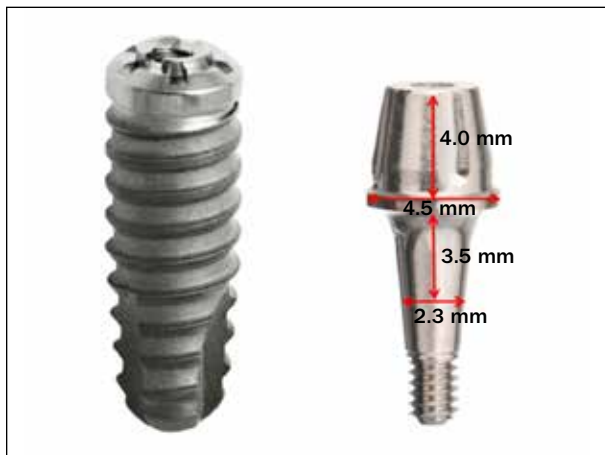
**Fig 1** (Left) The Morse cone implant used and (right) the original dimensions and form of the abutment.

For this research, four dental implants with a Morse taper connection (Implacil De Bortoli) with a diameter of 4.0 mm and a length of 11 mm were used (Fig 1a). Since this is a pilot study, the number of samples was determined by the ability of the test equipment

to work with four pieces simultaneously. Four straight abutments were used; these comprised a 3.5-mm-long transmucosal portion, a 4.0-mm-high baseplate prosthetic, and a 4.5-mm-diameter platform (Fig 1b).

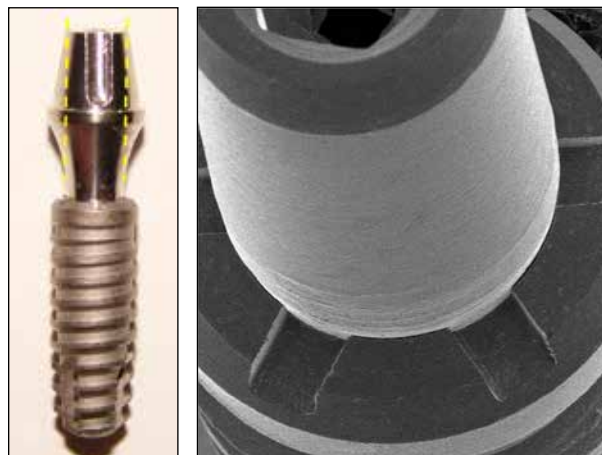
**Fig 2** (Left) The abutment/implant assembly before machining and (right) after machining to reduce the body of the abutment. The yellow lines show the portion of the abutment that was removed.

The junction between the abutment and a Morse taper implant is situated on the platform of the implant, providing the effect of platform switching. After emerging from the implant at 2.3 mm in diameter, the abutment increases in diameter to create an emergence profile that reaches 4.5 mm in diameter. Thus, it is possible to analyze this gap through direct visualization; images can be obtained from above, looking into the interface of the implant/abutment, so that the abutments can be machined to reduce their diameter, thereby removing this emergence profile (Figs 2a and 2b). This procedure was carried out in the machining division of the Implacil De Bortoli factory on a computerized lathe (Cincom C16 1M7A, Citizen) to ensure accuracy in the preparation of samples, which was done at low speed and with abundant irrigation to prevent changes in the metal structures. After machining, the upright abutments were washed with water in an ultrasonic tank for 20 minutes to remove residues from the cutting process.

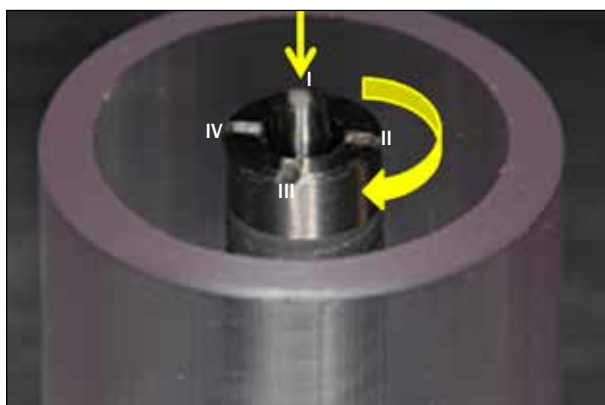
**Fig 3** View of the marks made on the implant platform to determine the locations of images acquired by SEM, starting at the position identified by the yellow arrow and continuing clockwise.

The entire surface of the abutment/implant in the implant platform was marked with a high-speed drill to identify four points (I, II, III, and IV) that divided the circumference of the implant platform into four equal parts. Marking of the locations of these lines, from which the images were obtained, was randomized (Fig 3). The images were always captured in a clockwise direction.

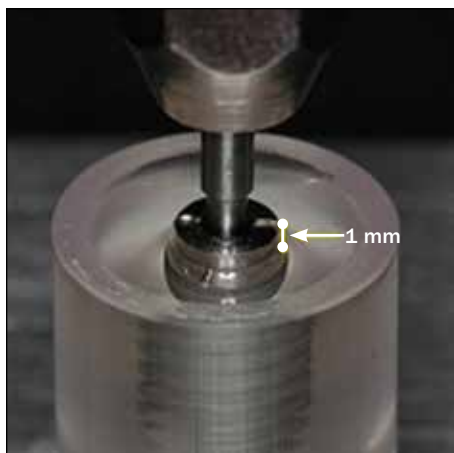
**Fig 4** The paralleling device used to position the resin sets; the yellow line represents the final distance from the resin to the implant platform.

With the sets centered, the resin was manipulated according to the instructions of the manufacturer. After the resin was mixed, the polyvinyl cylinders were filled with the resin to approximately 1 mm below the platform of the implant (Fig 4). This type of resin has a tensile modulus of  $0.21 \times 10^9$  N/m<sup>2</sup>, similar to the elastic modulus of human trabecular bone ( $0.14 \times 10^9$  N/m<sup>2</sup>).<sup>25</sup>

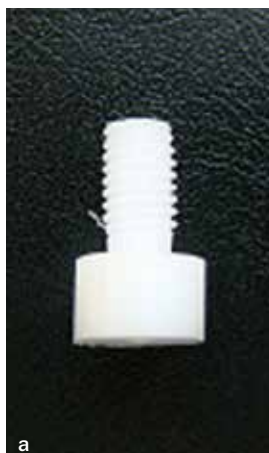
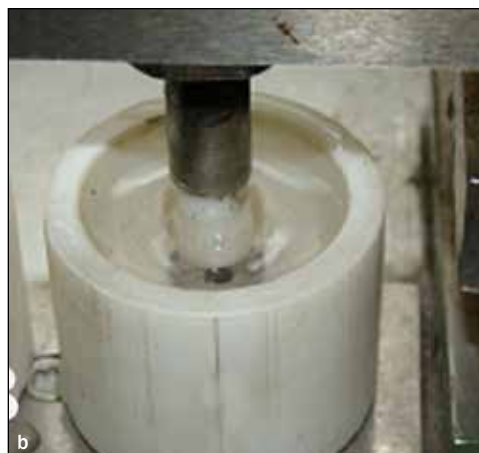
**Fig 5** (a) The polyacetal tip manufactured for testing. (b) The piston contact with the specimen, which was immersed in saline solution at a temperature of 37°C.

Final polymerization of the resin occurred within 72 hours in an oven at a controlled temperature of 60°C, after which the specimens were disconnected from the positioning devices. The fatigue tests of the four specimens were performed at the Department of Dental Materials, School of Dentistry, University of São Paulo in a mechanical cycling machine (Bio PDI, Biocycle). This machine had four pistons that were equipped with polyacetal tips (Fig 5), so that no direct impact occurred between the two metal surfaces.

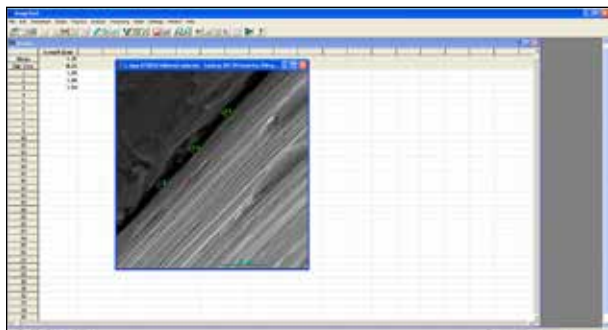
**Fig 6** Image of the measured gap in one of the samples, where L1 = the right measurement; L2 = the central measurement; L3 = the left measurement.

The images at the abutment/implant interface obtained under  $\times 5,000$  magnification ( $n = 32$ ) were used for measurements (quantitative analysis), which were performed with Image Tool (version 3.0 for Windows, University of Texas Health Science Center, San Antonio). These measurements were made at three points on each gap image (Fig 6): one in the center of each image and the other two on each side, 7  $\mu$ m from the center point. The average of these three measures was used as the reported value for each gap.

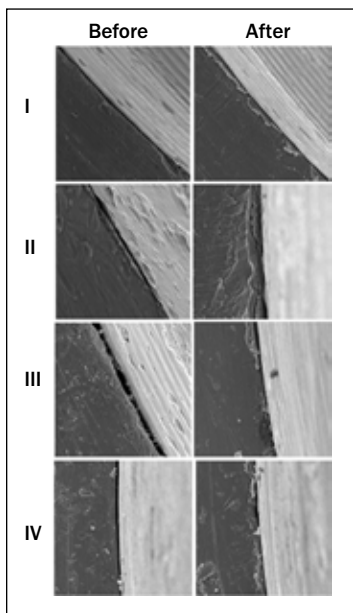
**Fig 7** Images of sets I, II, III, and IV taken at  $\times 1,000$  magnification. It is evident that the implant-abutment gaps decreased after mechanical cycling.

When the images were compared, it was evident that, after cycling, there was an approximation between the walls of the implant and the abutment that reduced the existing gap initially. More “barbs” were present on the abutments, suggesting that there was deformation

of the abutment and intrusion (via loading) into the implant. This increased friction between the walls of these components increased the degree of union, which is also called “cold soldering.” The differences in the interface before and after cycling are apparent from the images, which reveal a decrease in the size of the interface after mechanical cycling (Fig 7).

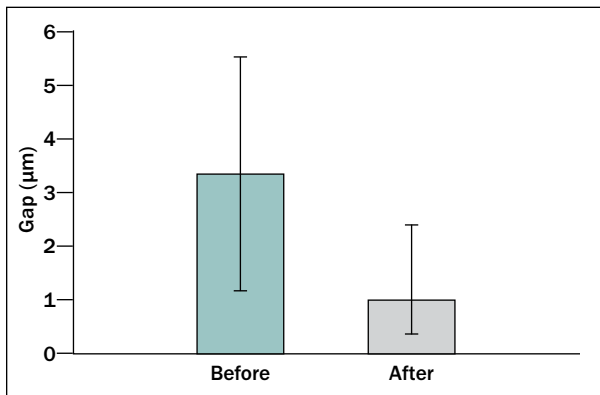
**Fig 8** Comparison of the average gaps (with standard deviations) in the samples before and after mechanical cycling.

The measurements of the implant/abutment gaps were tabulated in a spreadsheet, and the average measurements were obtained from each quadrant. These data were used to generate a chart comparing the gaps measured before and after mechanical cycling (Fig 8).

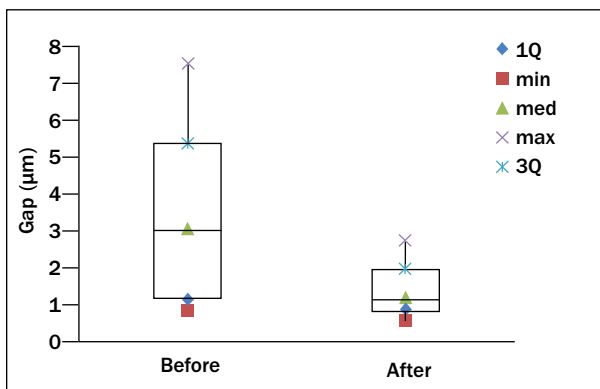
**Fig 9** Comparisons of the sizes of the gaps measured in the four sets before and after mechanical cycling. 1Q = first quartile; min = minimum; med = median; max = maximum; 3Q = third quartile.

The average preload size of the gap was  $3.34 \pm 2.17$   $\mu\text{m}$ , and the average size of the gap after loading was  $1.35 \pm 0.64$   $\mu\text{m}$ , illustrating a decrease in the cracks

after cycling, which simulated mastication. After analysis of the second graph (Fig 9), it became evident that there was a decrease in the sizes of the gaps between the abutments and implants after mechanical cycling. The differences in the mean sizes of the analyzed gaps were significant ( $P = .0006$ ).
